Manhole Inspection Summary

Manhole # S21C__029MH

Insp Date: **9/21/09 11:38 AM**

Location Address: **508 KIRBY-FULTON**

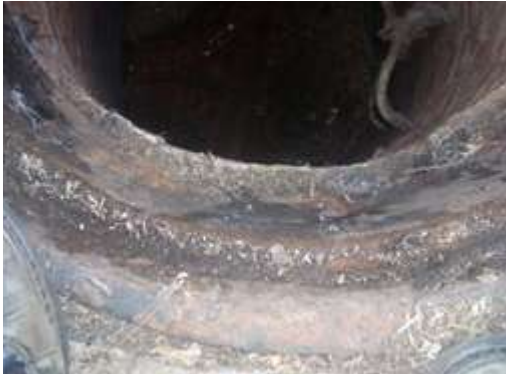
Defect 1

Offset: **1** (in.)

FRAME OFFSET

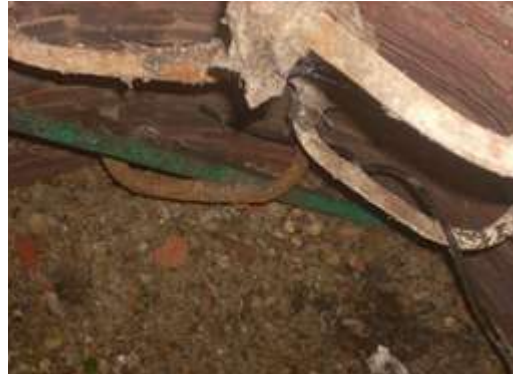
Defect 2

Count: **5** Missing: **0** ☒ **Corroded**

CORRODED STEP

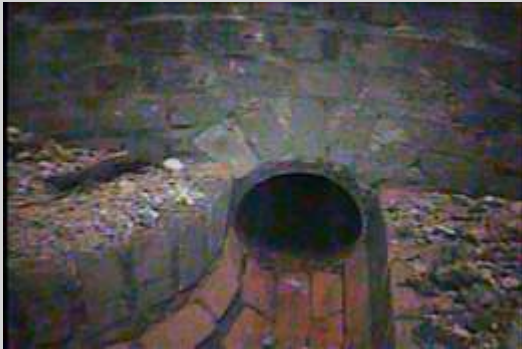
12 O'Clock Outflow

8 in. Circular Gravity Sewer
Pipe Out @ 12 O'Clock

Pipe Height: **7.2** (in.) Rod and Bar (Angled)
Pipe Material: **Clay** ☐ Pipe Lined
Invert Depth: **8.95** (ft.) Flow Characteristics: **Slow**
Deposits: ☒ None ☐ Mud ☐ Sludge ☐ Debris ☐ Grease
Silt Depth: (in.) Deposits Extent:
Infiltration: **None** Pipe Seal Cond: **Sound**

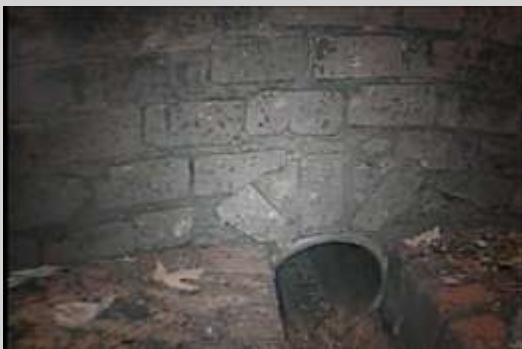
6 O'Clock Inflow

6 in. Circular Gravity Sewer
Pipe In @ 6 O'Clock

Pipe Height: **6** (in.) Rod and Bar (Angled)
Pipe Material: **Clay** ☐ Pipe Lined
Invert Depth: **8.72** (ft.) Flow Characteristics: **None**
Deposits: ☐ None ☒ **Mud** ☐ Sludge ☐ Debris ☐ Grease
Silt Depth: **1** (in.) Deposits Extent: **Light**
Infiltration: **None** Pipe Seal Cond: **Sound**

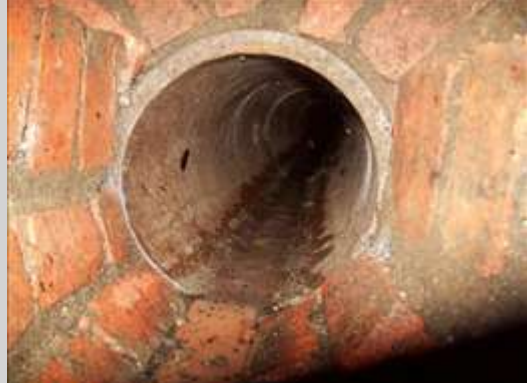
9 O'Clock Inflow

8 in. Circular Gravity Sewer

Pipe In @ 9 O'Clock

Deposits: ☒ None ☐ Mud ☐ Sludge ☐ Debris ☐ Grease

Infiltration: **None** Pipe Seal Cond: **Sound**
